CONCRETE PAVEMENT RESTORATION

The Georgia Story

Georgia boasts smoothest roads

Georgia manages its road deterioration problems through a dedicated use of the CPR maintenance system

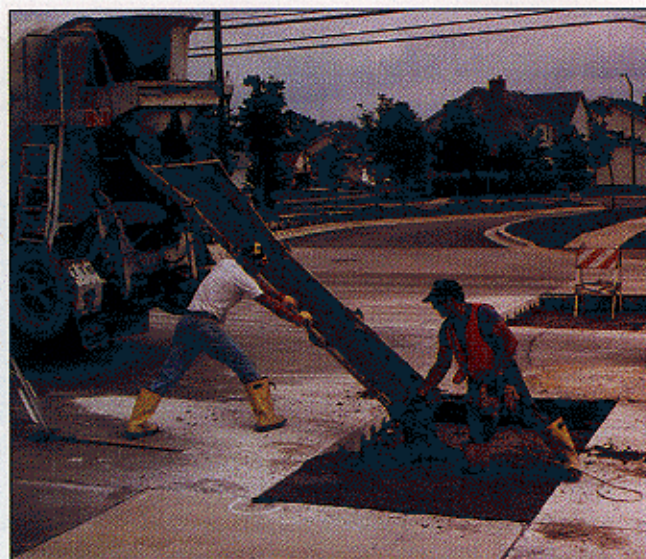
Full-slab replacement is one procedure of the CPR maintenance system

Slab replacement has been a very successful procedure for Georgia. After using the lift out method to remove the slab, they remove some base in order to give themselves the option of increasing the concrete thickness. The new slab is joined to the existing roadway with dowels.

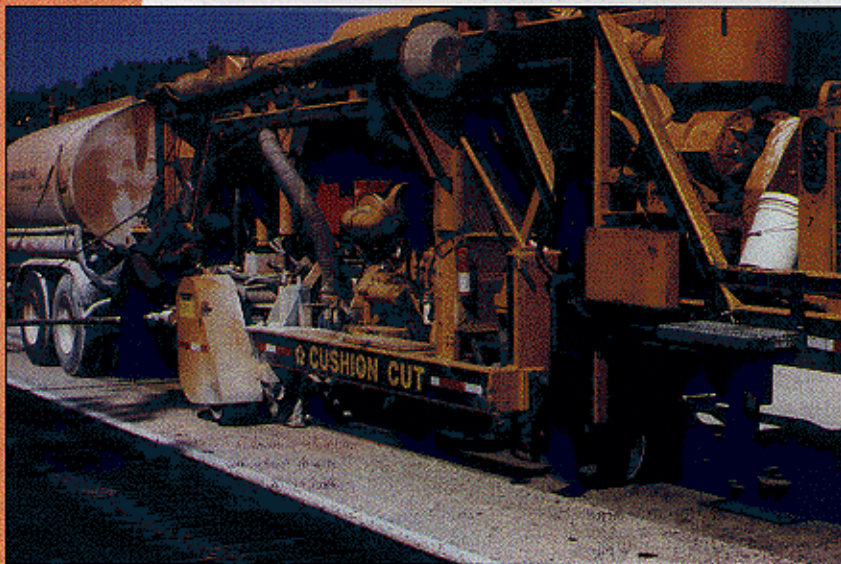
A diamond grinding machine at work on Georgia's I-16.

Diamond grinding involves the use of diamond blades gang-mounted on a horizontal grinding head. As the grinding machine moves over the pavement, the grinding head rotates and shaves off from 0.06 to 0.75 in. of the surface, leaving behind a corduroy texture. Diamond grinding is very effective in shaving down bumps, reprofiling rough lanes and smoothing pavements. The corduroy texture also helps reduce hydroplaning by providing displacement channels for water.
